TOWN OF HAYMARKET PLANNING COMMISSION

III. Public Hearing SUP#2019-004 Van Metre/Smith Property

SPECIAL USE PERMIT PLAN FOR SMITH PROPERTY AT HAYMARKET

Smith Properties - Haymarket Traffic Impact Statement

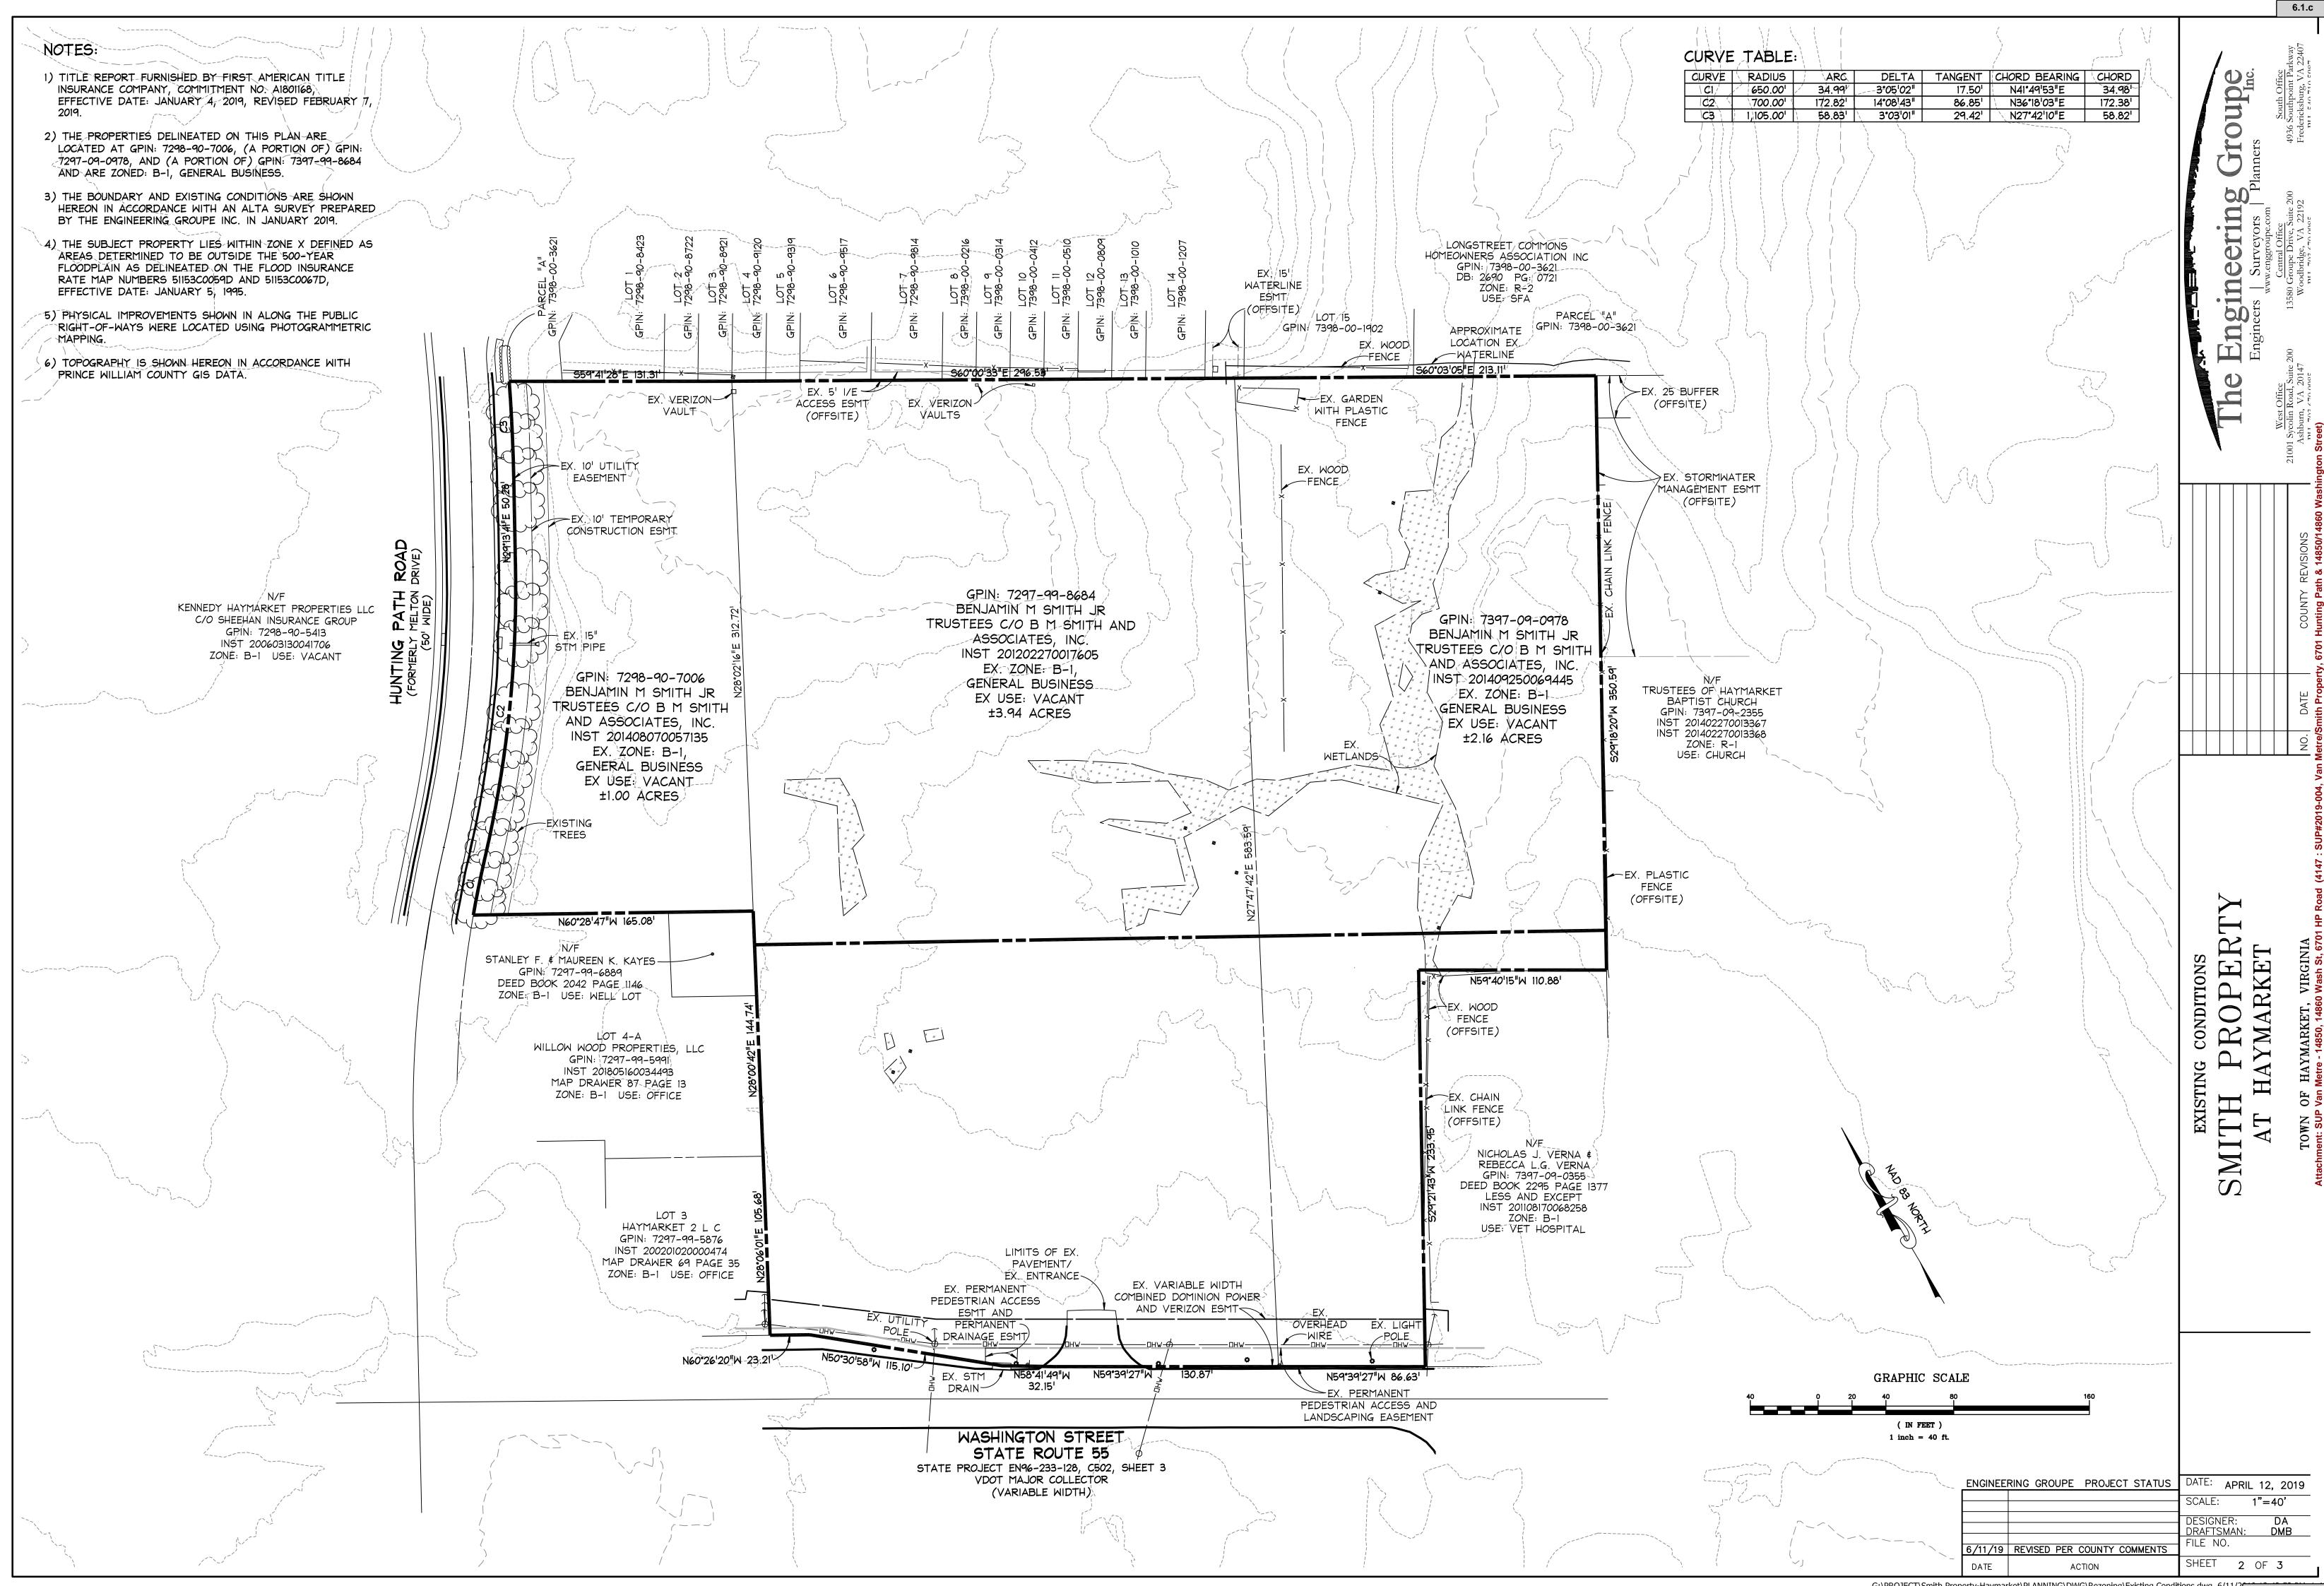
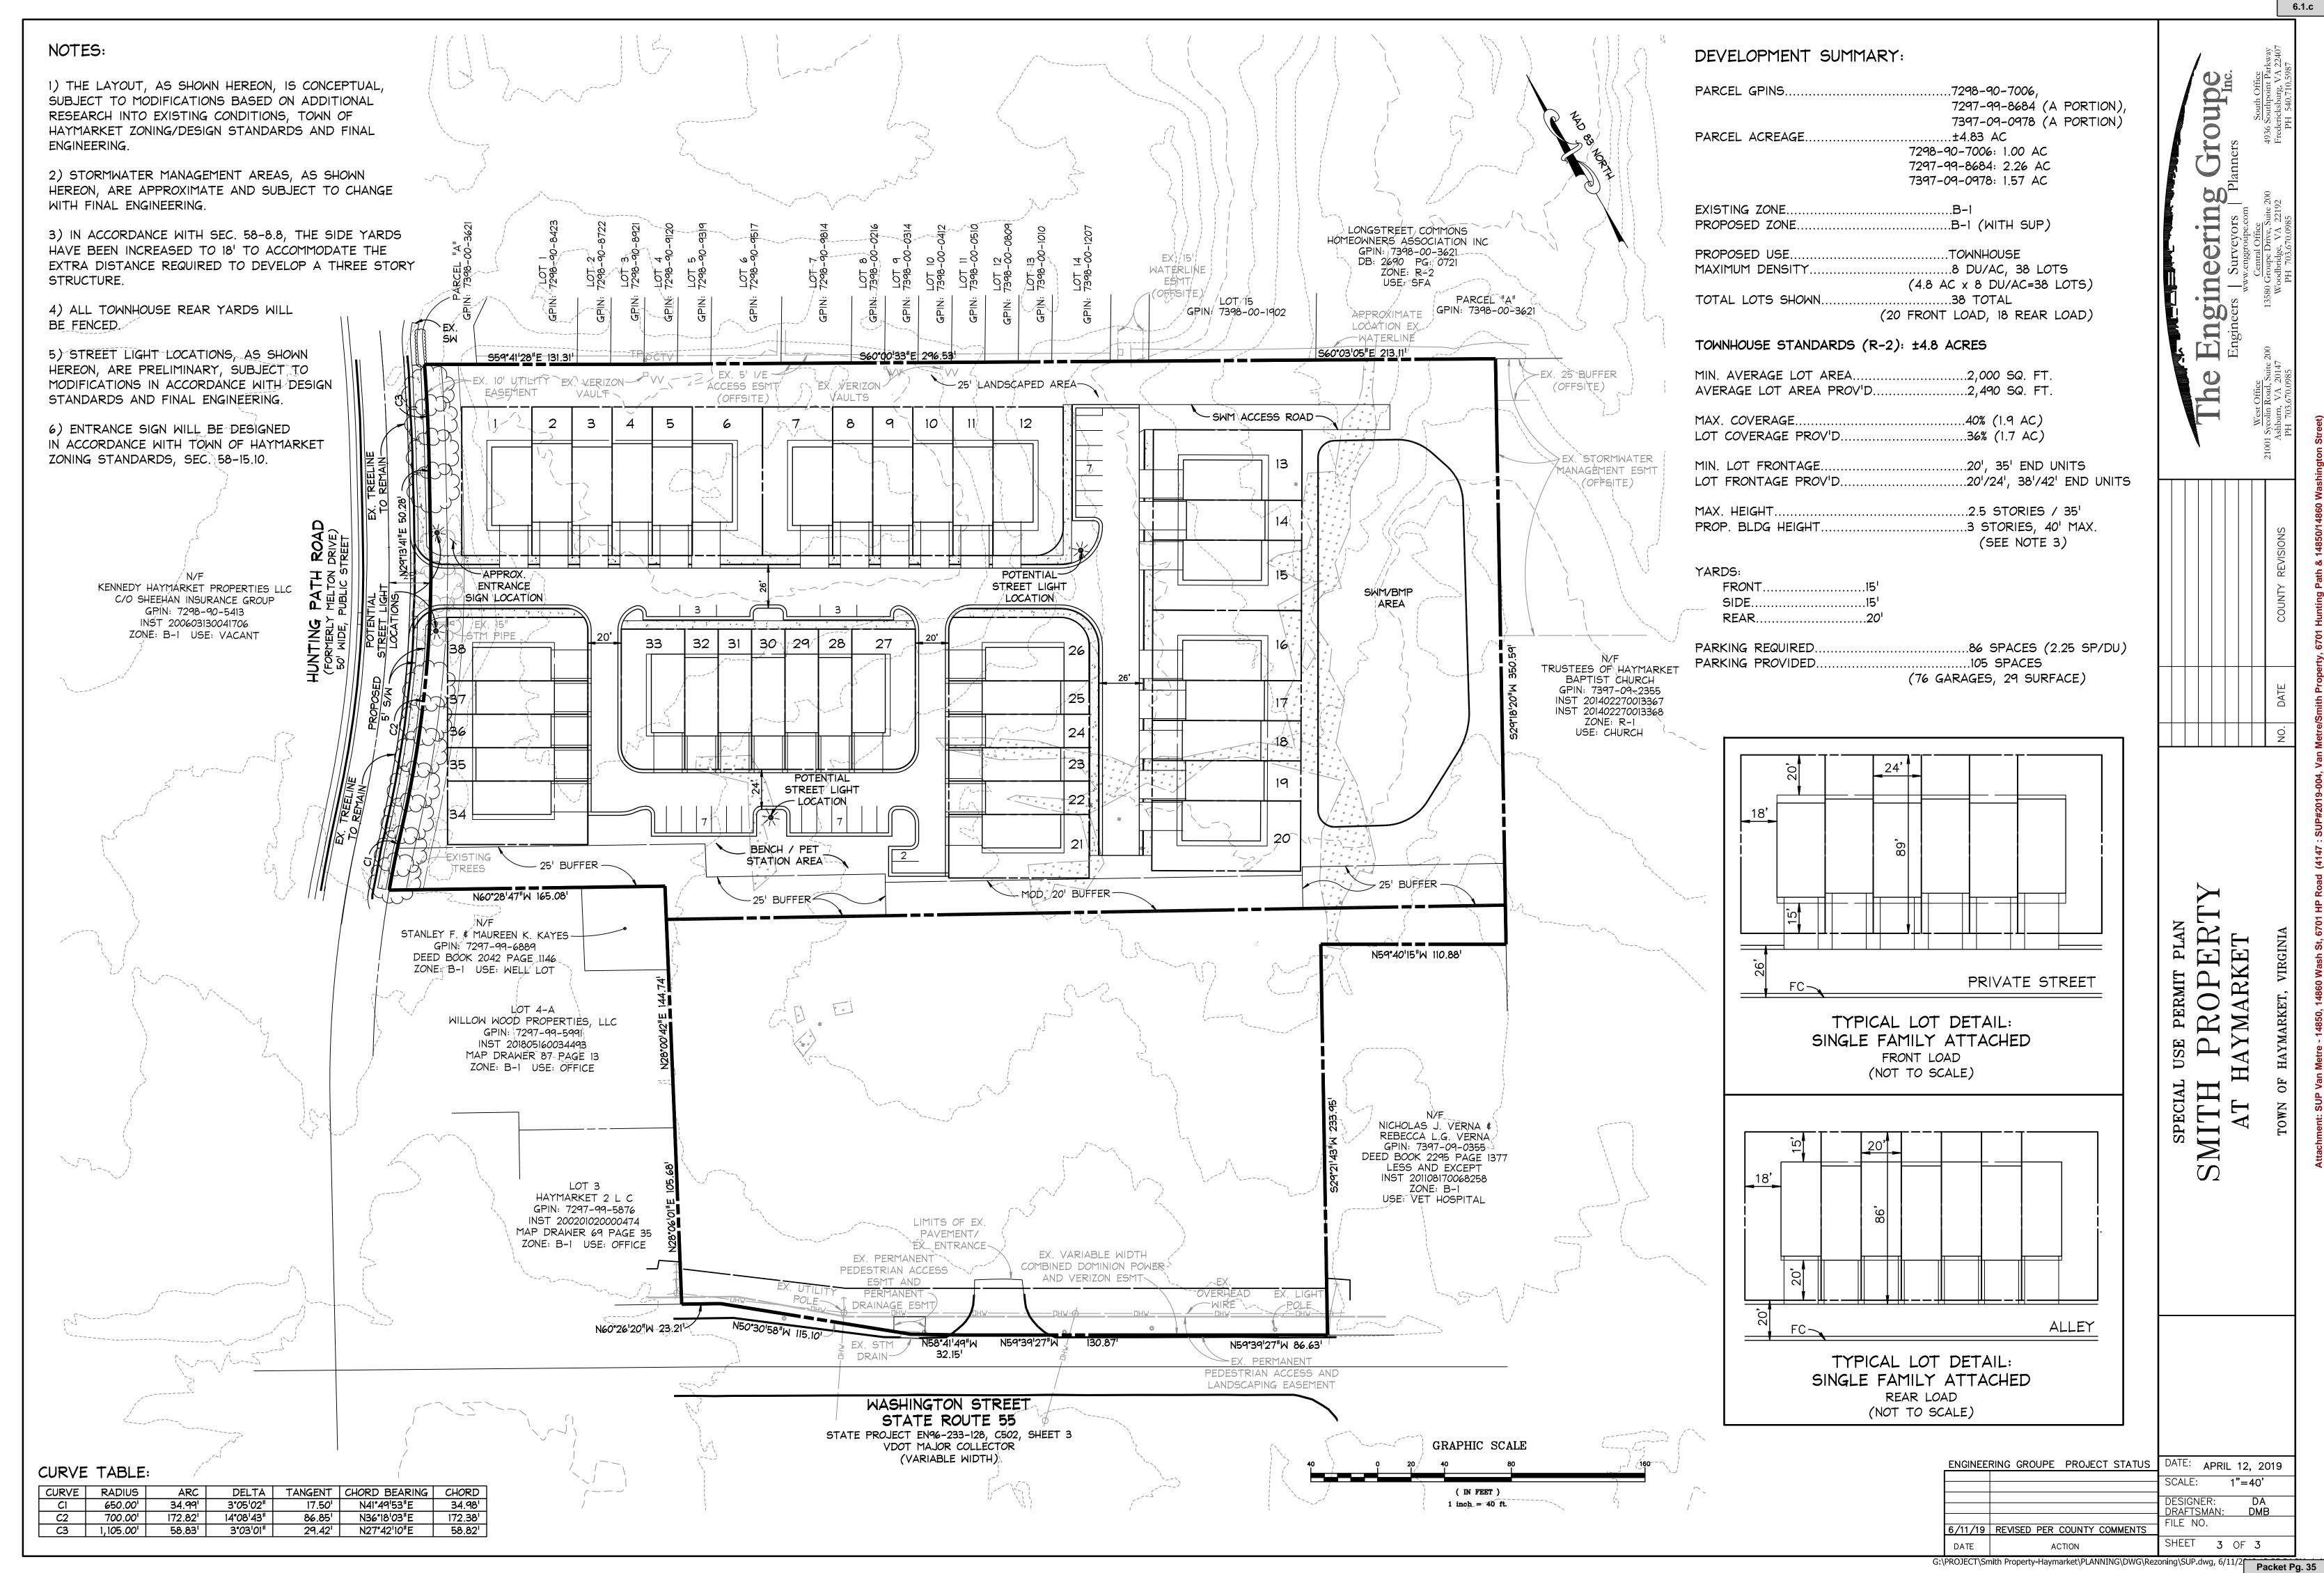
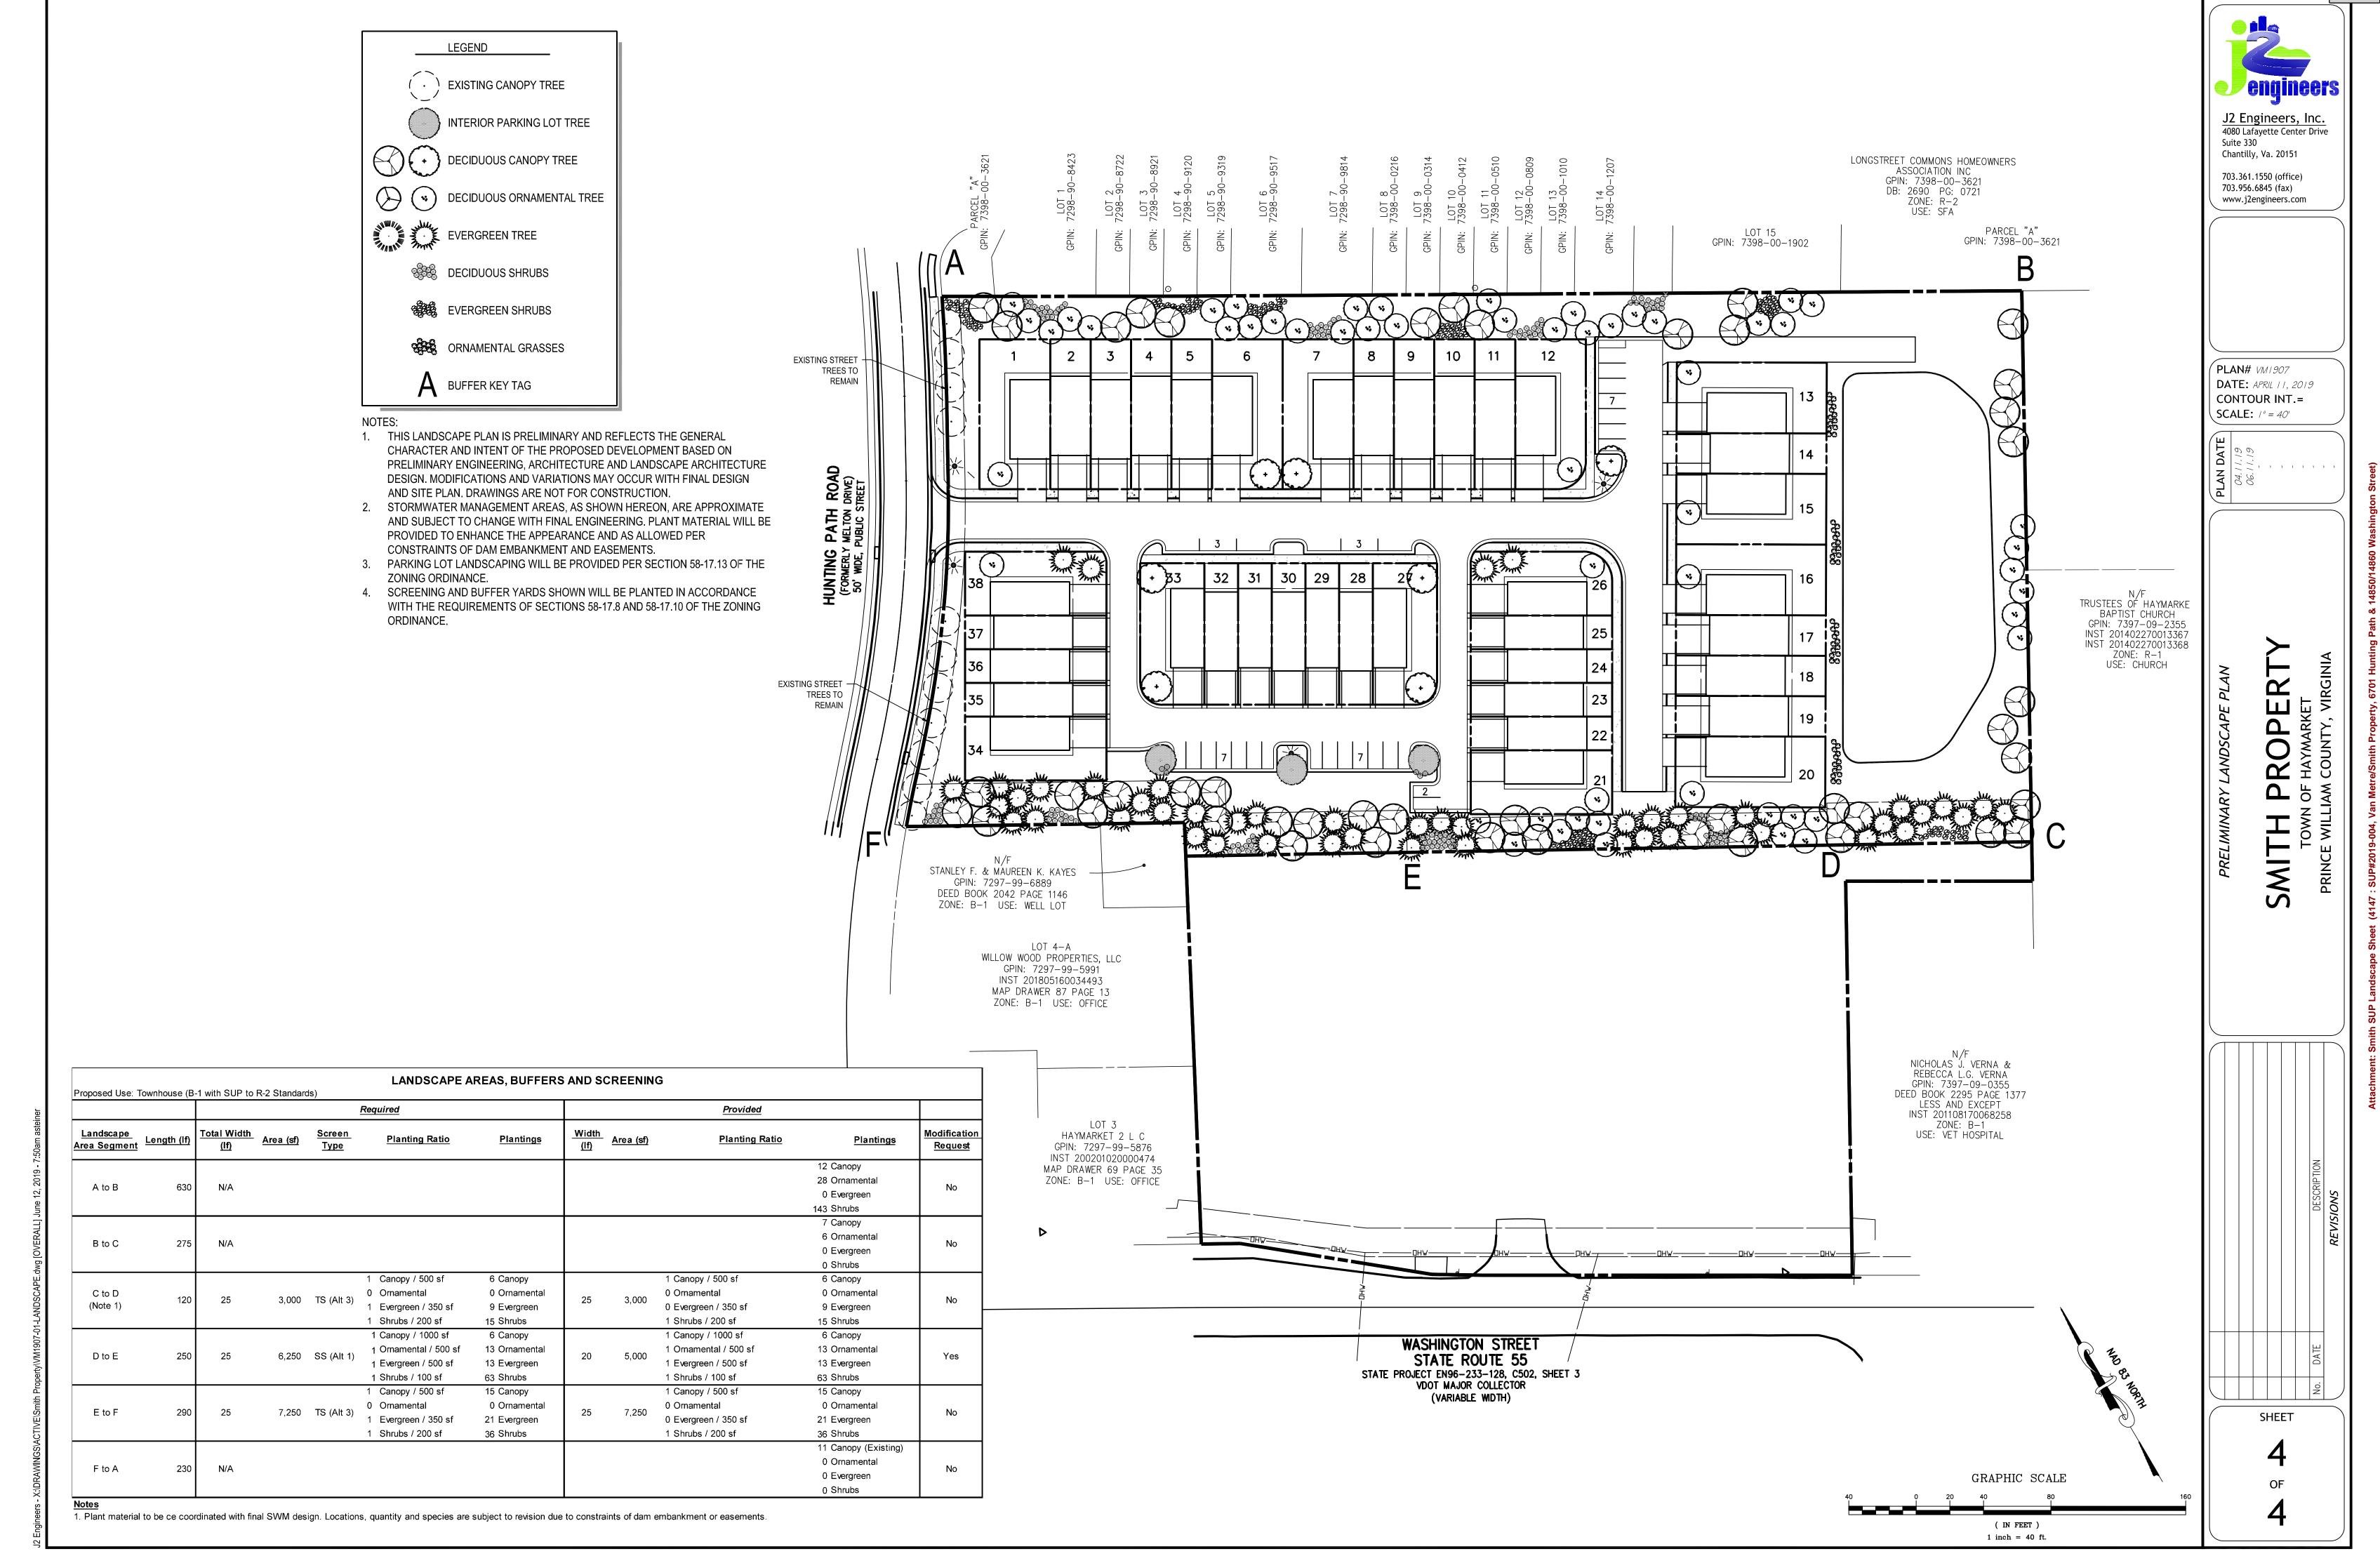
COVER SHEET
SMITH PROPEF
AT HAYMARKET

2. EXISTING CONDITIONS PLAN 3. SPECIAL USE PERMIT PLAN

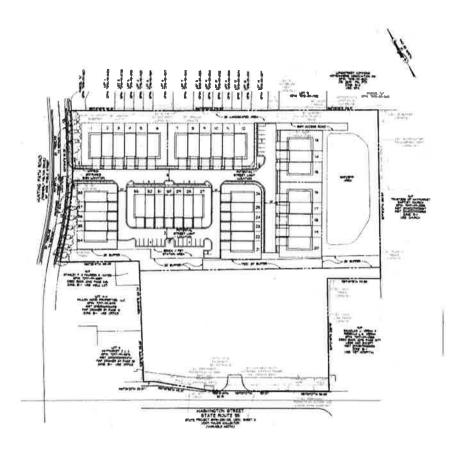
Exhibit 2: Site Concept Plan (Source: The Engineering Groupe, excerpted by Pennoni)

The proposed site plan would develop 38 townhome DU on 4.8± acres of the total 7.1± acres east of Hunting Path Road. This residential development is proposed to have a single ingress/egress point on Hunting Path Road (Rte. 1304), north of the existing commercial entrances and south of the Cheyenne Way/ Rising Sun Road intersection. The site area fronting on Washington Street is not included in the special use permit request. Development of this area is included in the background growth. No interparcel access is envisioned. The concept plan is shown below as Exhibit 2.

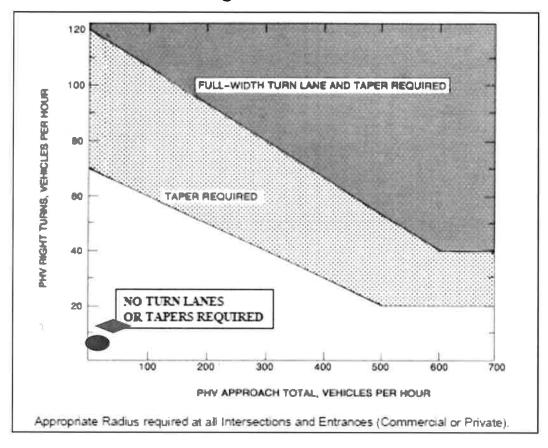
2028 Total Conditions Hunting Path Road & Site Entrance NB Right-Turn Lane

Peak Hour:	AM	PM
Hunting Path Road	NB	NB
NB Approach Total	15 VPH	33 VPH
Right Turns	5 VPH	12 VPH
% Right Turns	33.3%	36.4%
Right Turn Vol Adjusted?	No	No

Right Turn Lane Warrant - NOT SATISFIED

For left turn warrants, the warrant is a function of speed, percentage left and the x and y variables in the charts in VDOT Appendix F figures F3-5 and F3-8 are based on opposing volumes (vertical axis) and advancing volumes (horizontal axis). The VDOT left turn graphs are based on design speed ranging from 40 to 60 MPH. To account for lower speed conditions for Hunting Path Road, the 40 MPH curves are used as initial test. However, the warrant sensitivity also interpolates the results to develop thresholds for a 30 MPH speed, which would relate to the 25 MPH speed on Hunting Path Road, based on the advancing volumes (Va.) in the VDOT Road Design Manual Appendix F Table 3-1. Pennoni has interpolated the table volumes for design speed changes, these interpolated graphs are also included in Appendix E. Table 8 summarizes the turn lane warrant results.

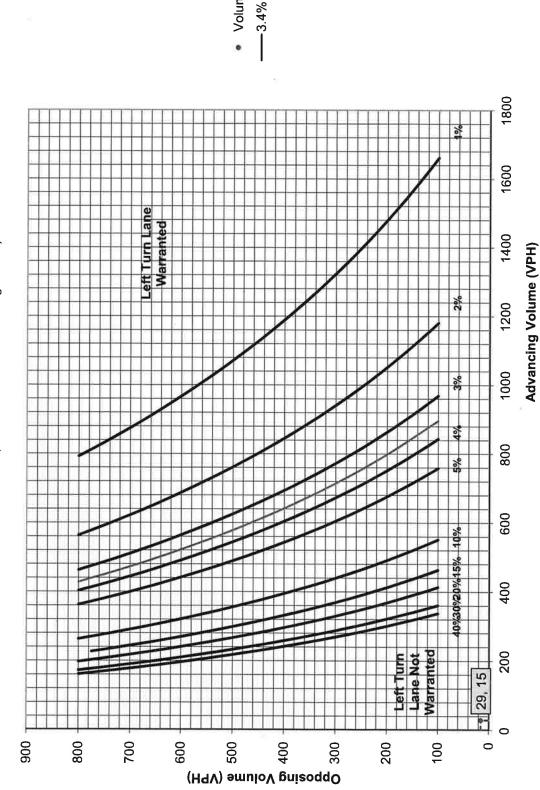
2028 Total Conditions Hunting Path Road & Site Entrance

SB Left-Turn Lane (speeds to 35 mph, unsignalized and signalized intersections)

(L = % Left Turns in Advancing Volume)

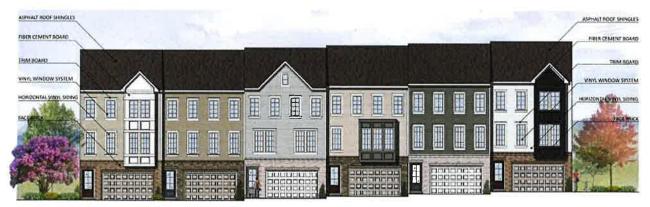
Front-Load Townhome

Two types of housing will be located within the residential neighborhood: front-load garage townhomes, located along northern and eastern sides of the parcel, and rearload garage townhomes, located along southern and western sides of the parcel. The rear-load garage townhomes are grouped to orient the primary front elevation towards Hunting Path Road and the main internal entrance road.
